Road Inspection Form

File ID	Local Name	Stratum	From - To KM	Current State	Risk	Inspection Frequency
7458-01	Adams West	1	0.000 - 81.157	Industrial	Medium	2

Inspection Date	Inspection Number	Reason for Inspection	Method	Inspected By
2026-03-15	125-10	annual	field visit	Bailey

Notes
Annual inspection to confirm compliance items & that the obligation to maintain this road is being met.

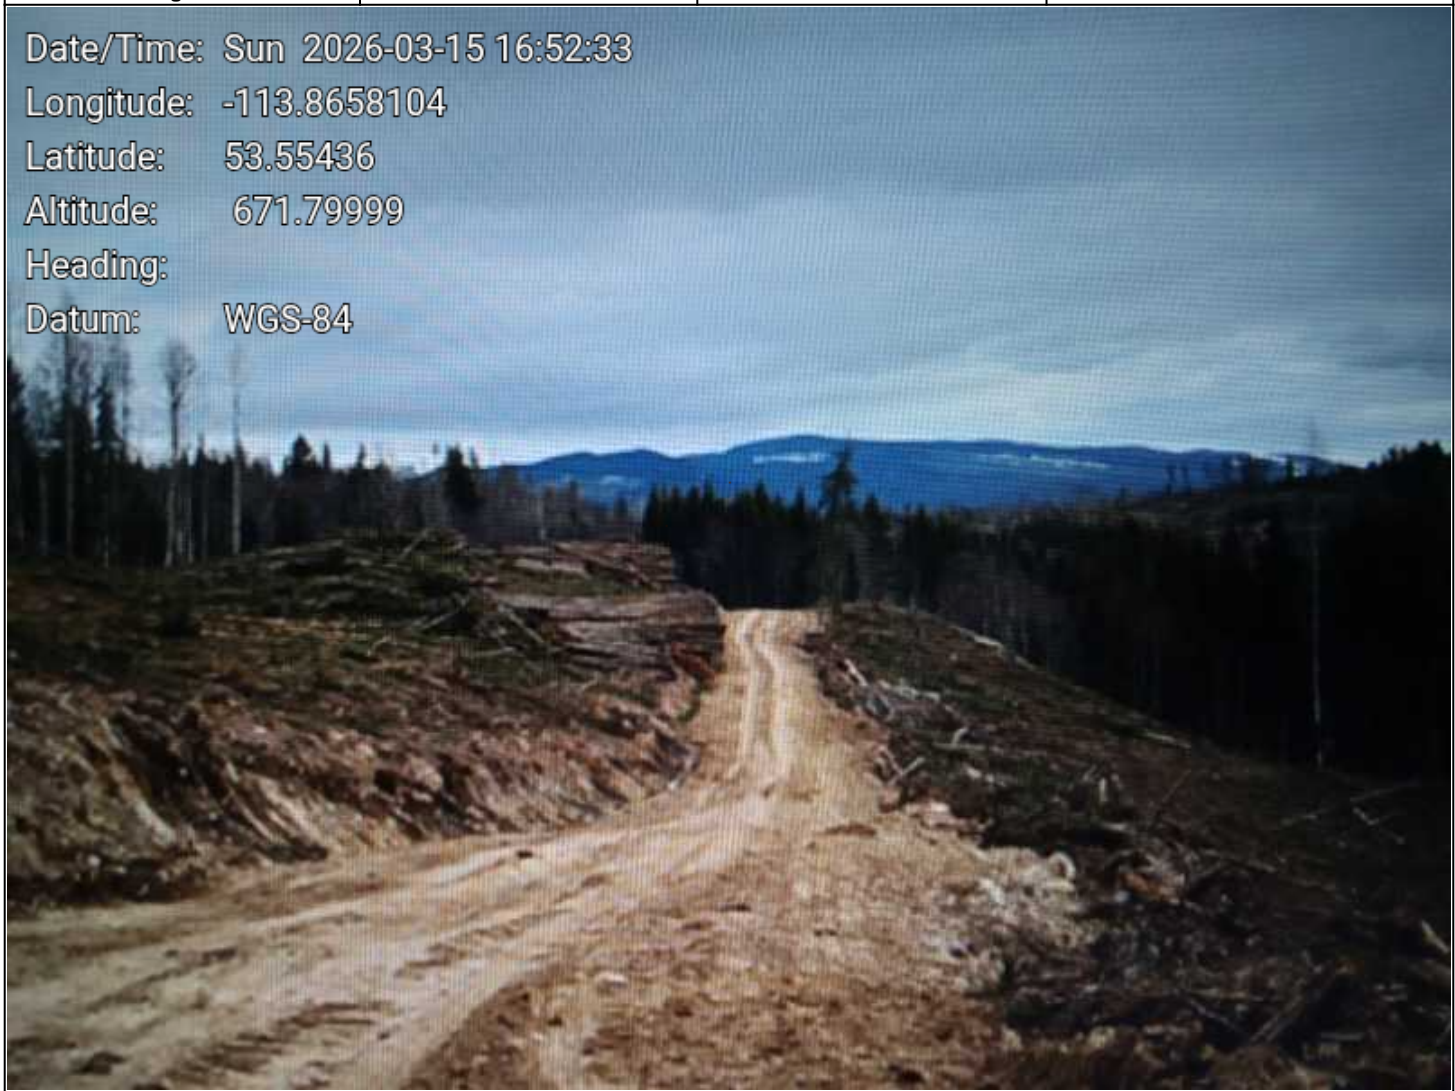
Notes:					
Washout	50.000 - 51.500	1.500	Culvert installation	H	2026-03-15

Notes: Field crew set out Hazard warning signs set on either side of the washout. Notified roads supervisor
